# BRAND SCHUTZ FORUM MÜNCHEN

Hochhausbrand Grenfell Tower –  
Erkenntnisse für den Brandschutz  
mehrgeschossiger Gebäude

Grenfell Tower Fire – London - 14.06.2017

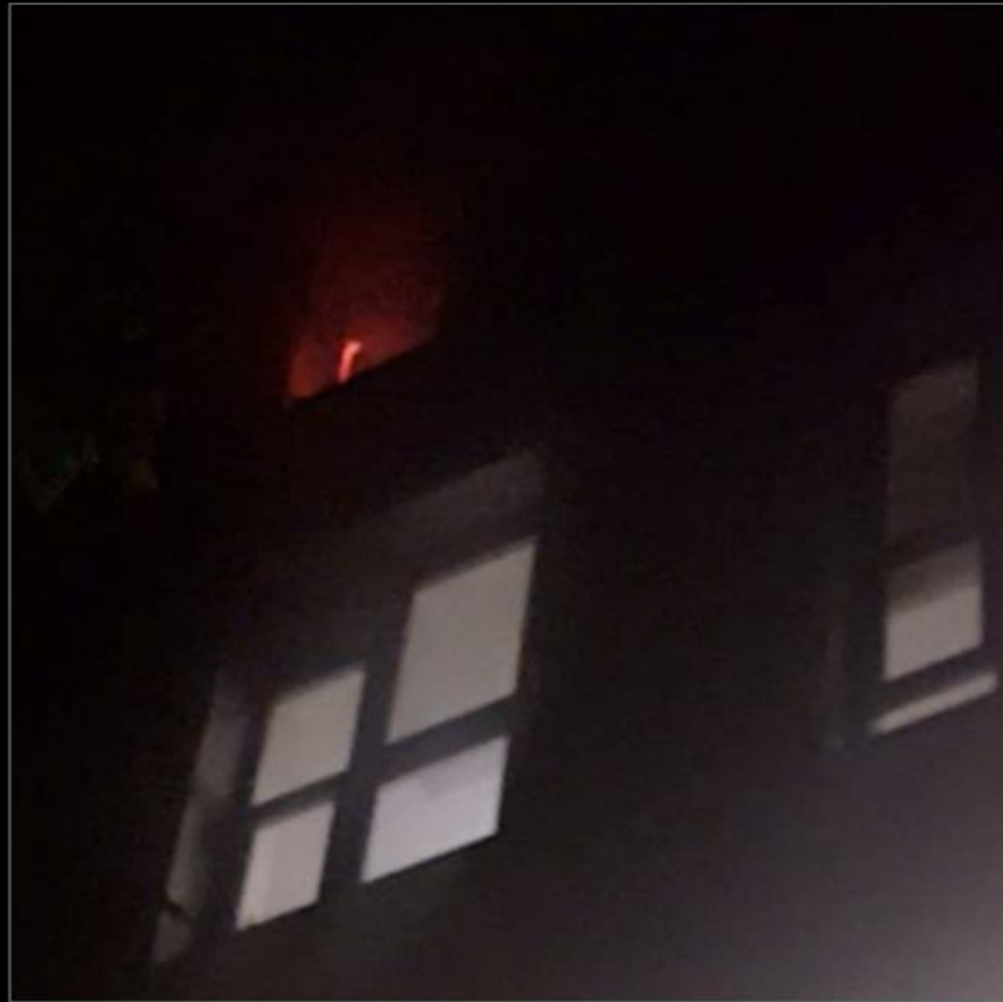
# First Image of Fire

01:05

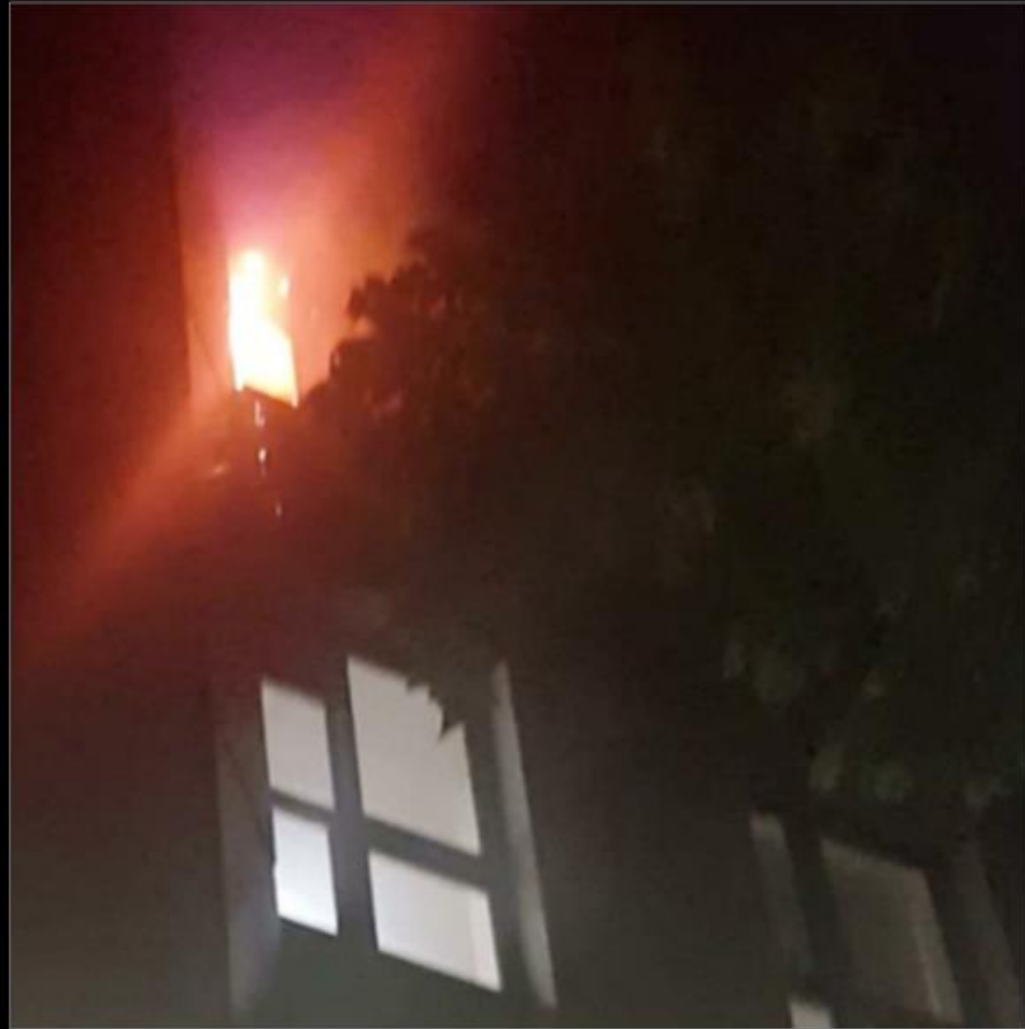
# First Evidence of Spread to Cladding

01:09

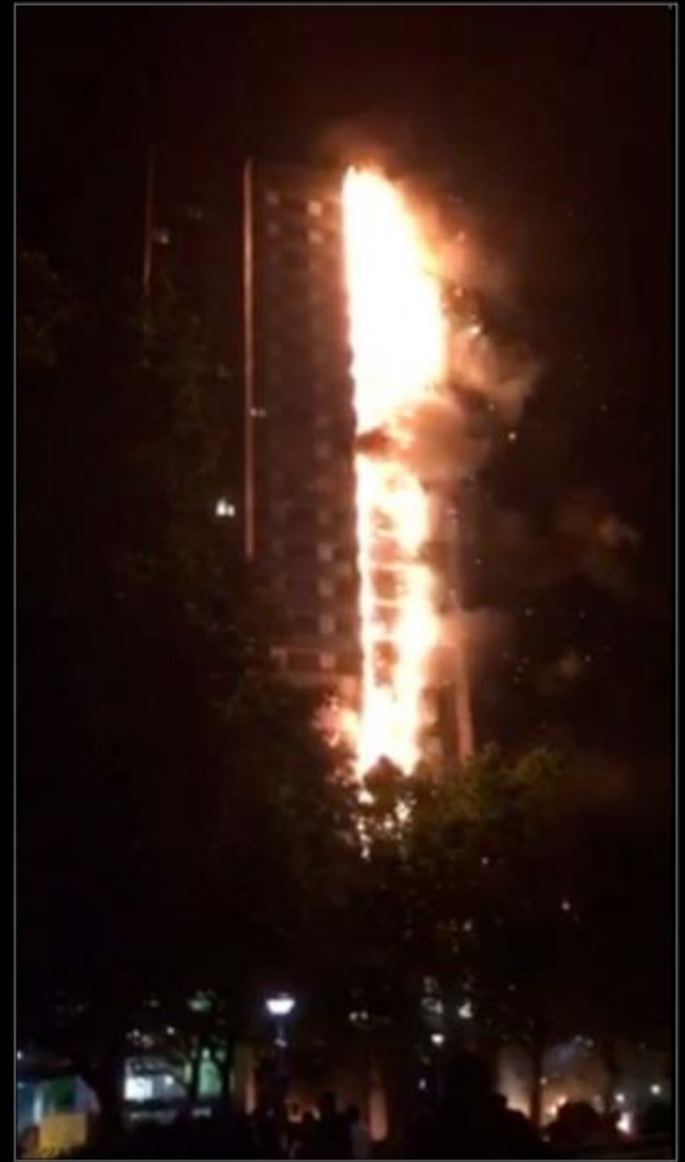
# Fire Spread to Top of East Face

01:29

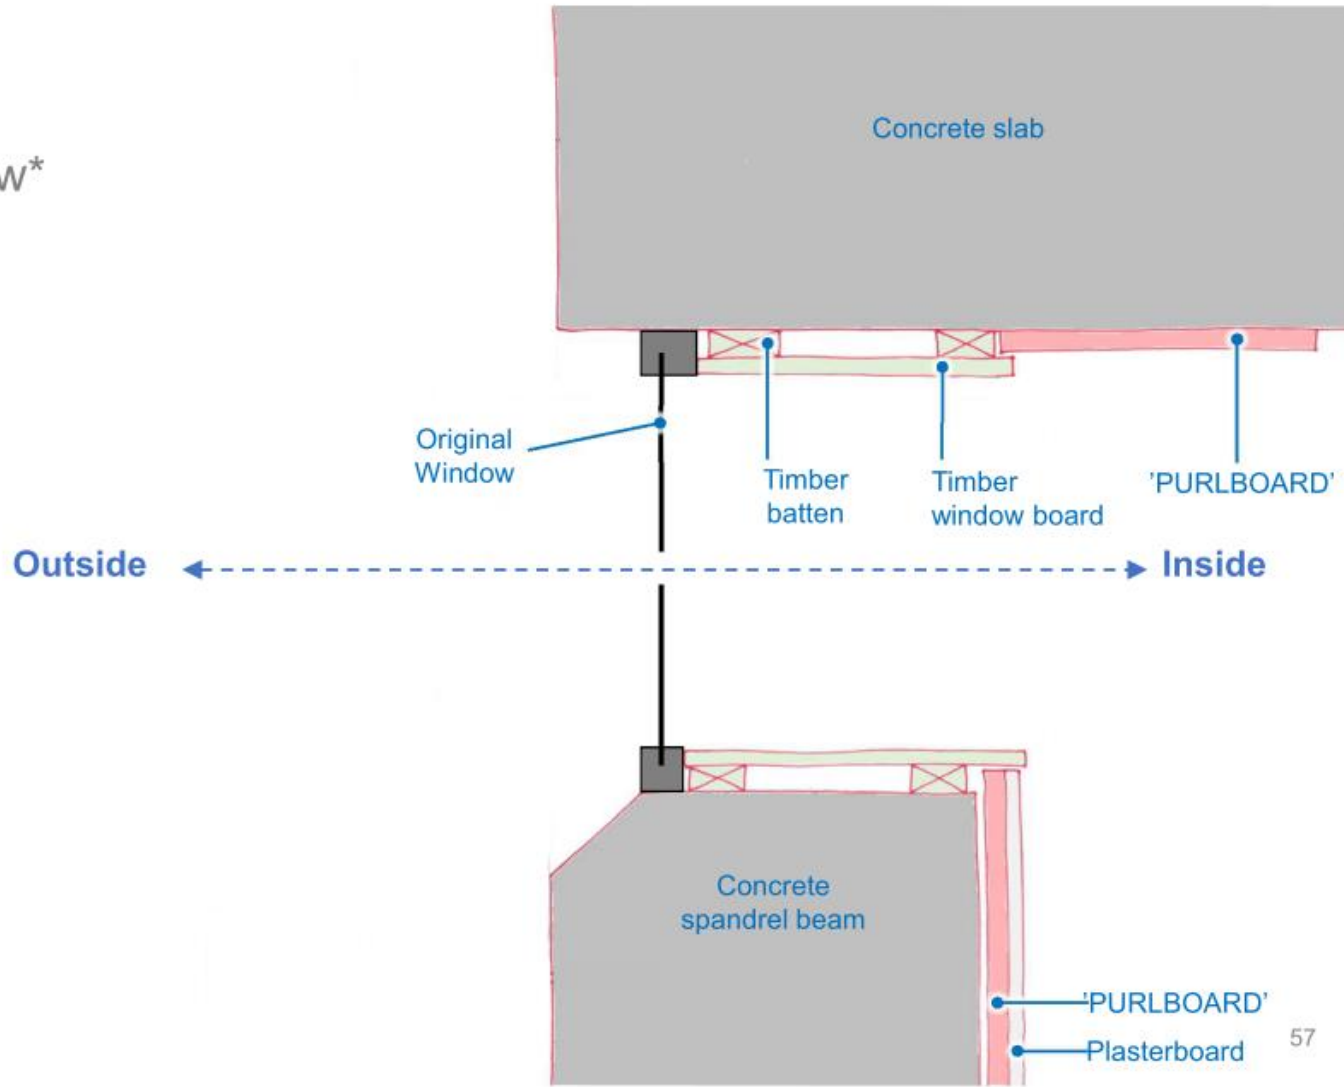
# Vertical Section

Through Kitchen Window\*

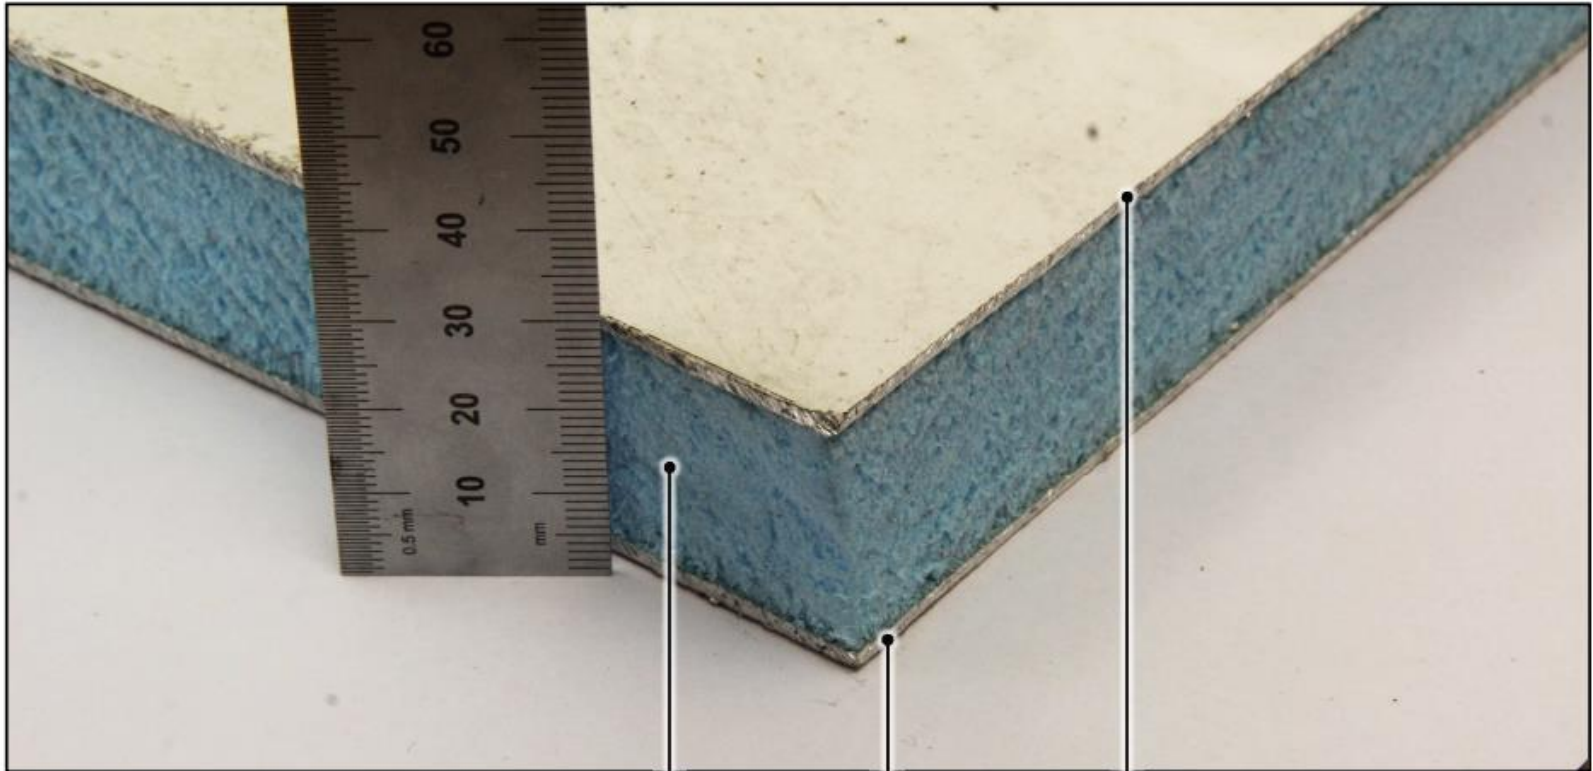
# Window Infill Panels

PS foam insulation  
core

Aluminium  
sheet

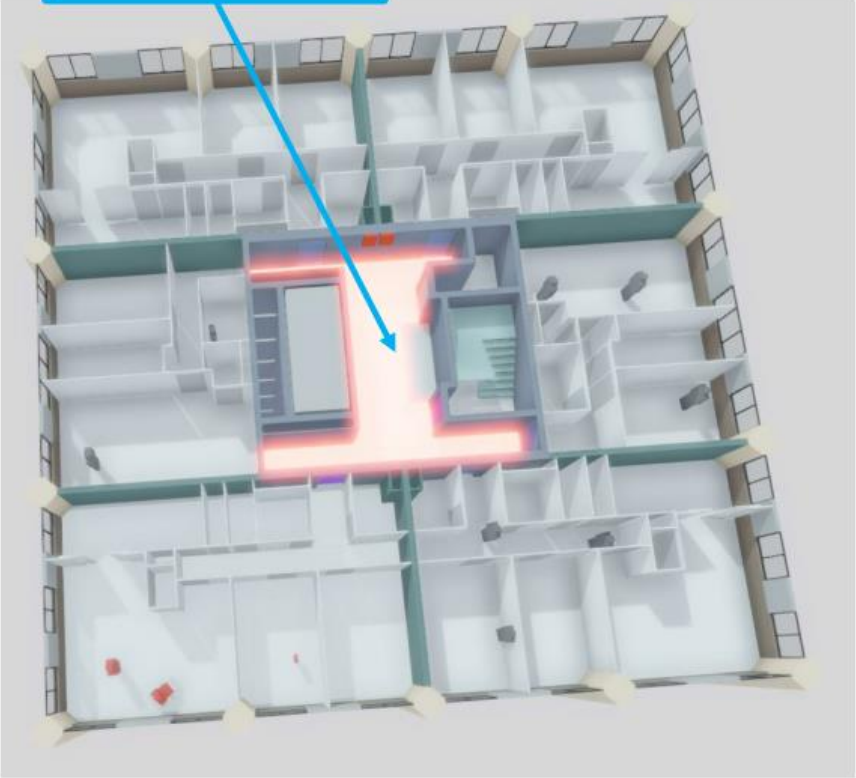
Original guidance for location - lobby

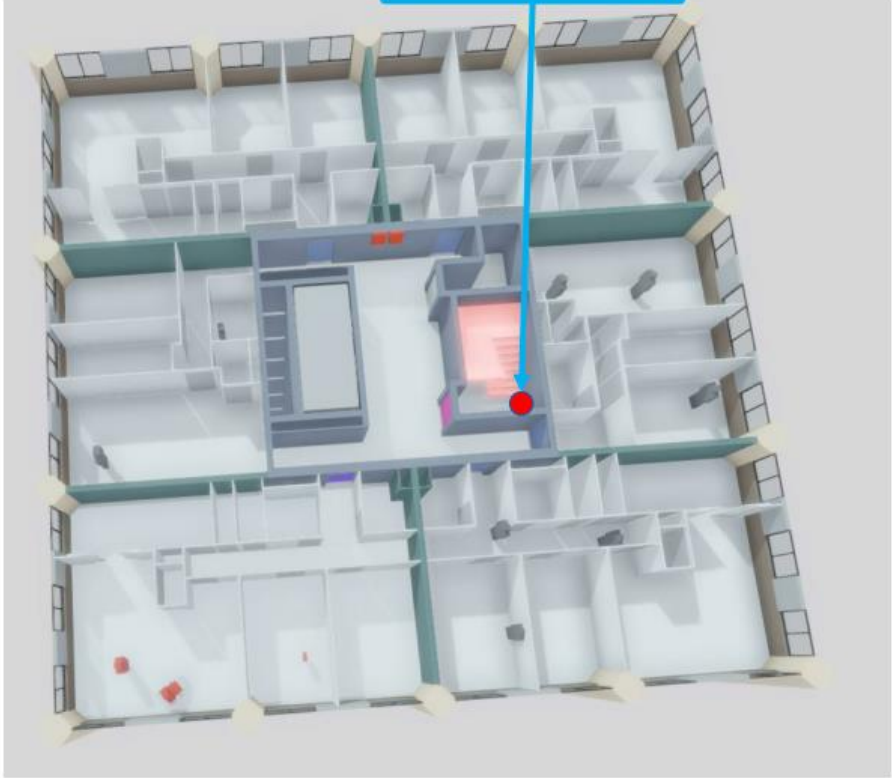
Current guidance for location - Stair

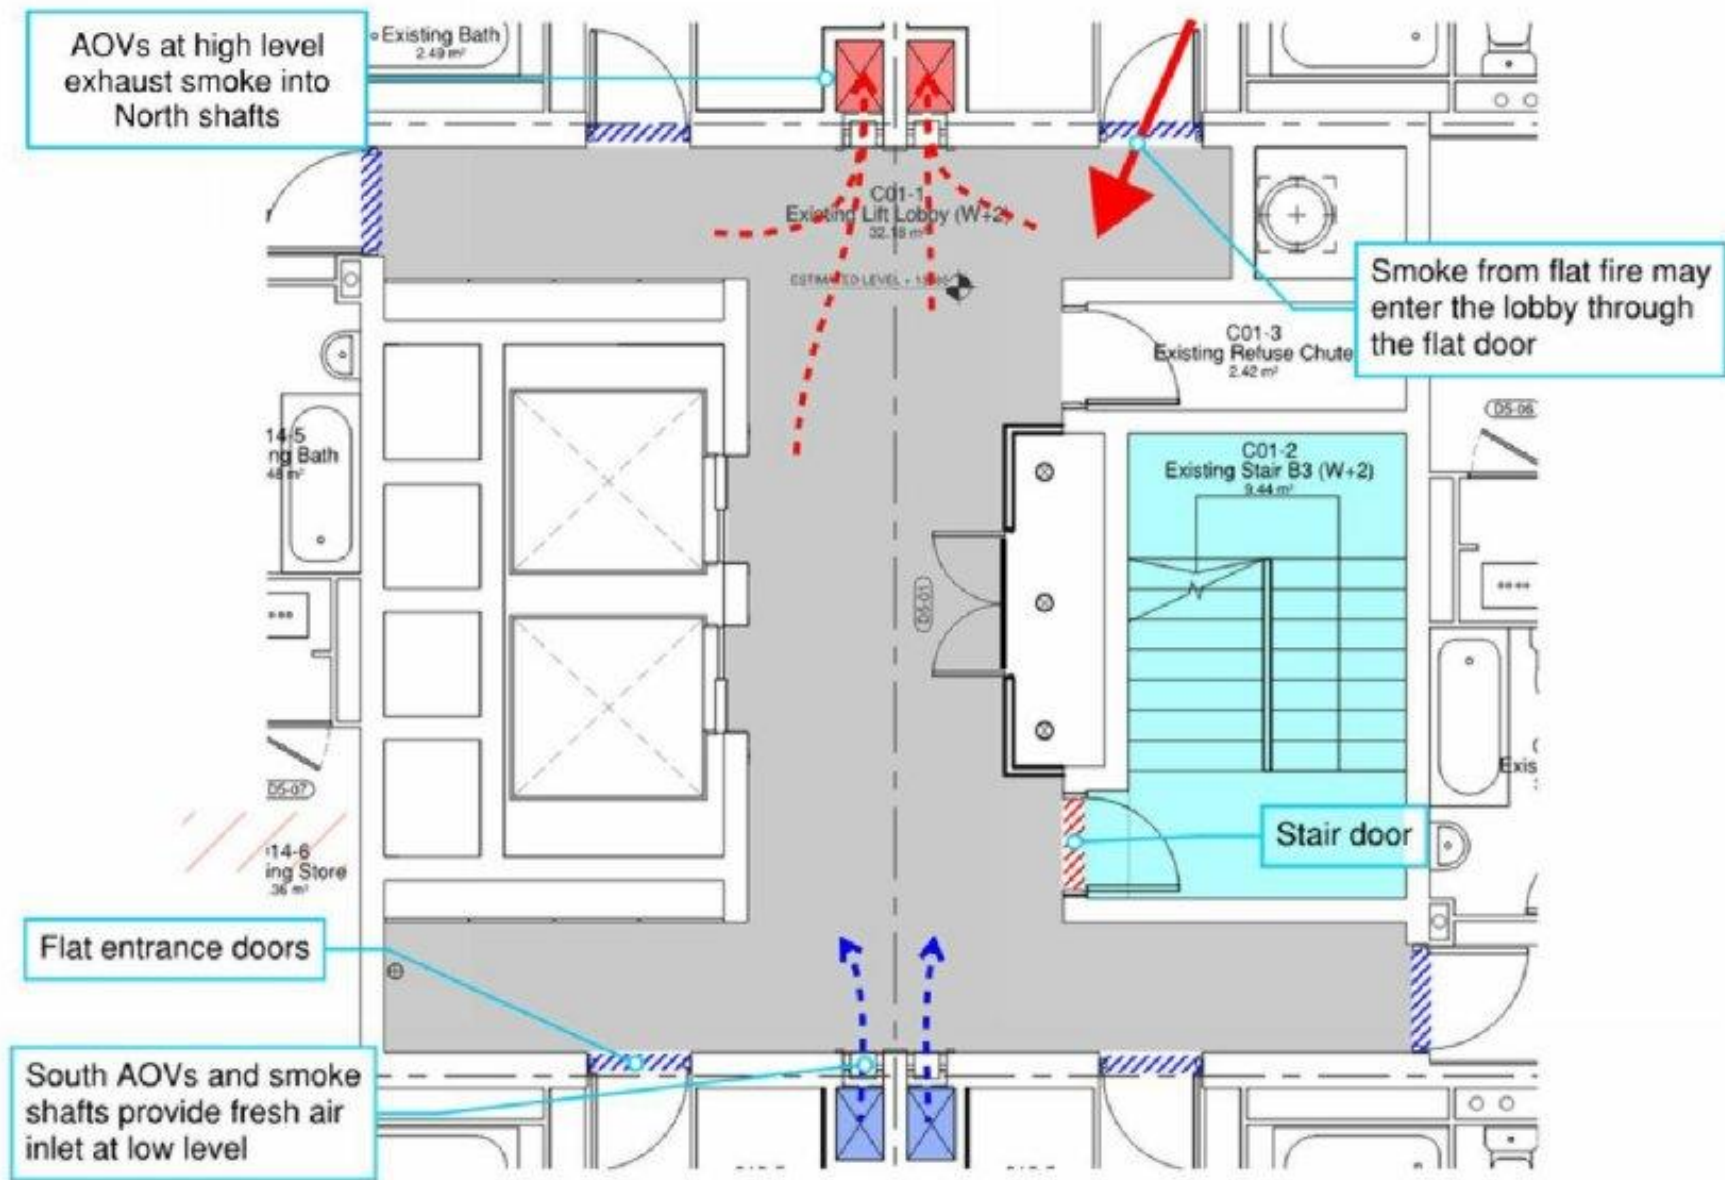
Figure J.5: Operation of the original smoke ventilation system on the fire floor, overlaid on an excerpt from SEA00010474.

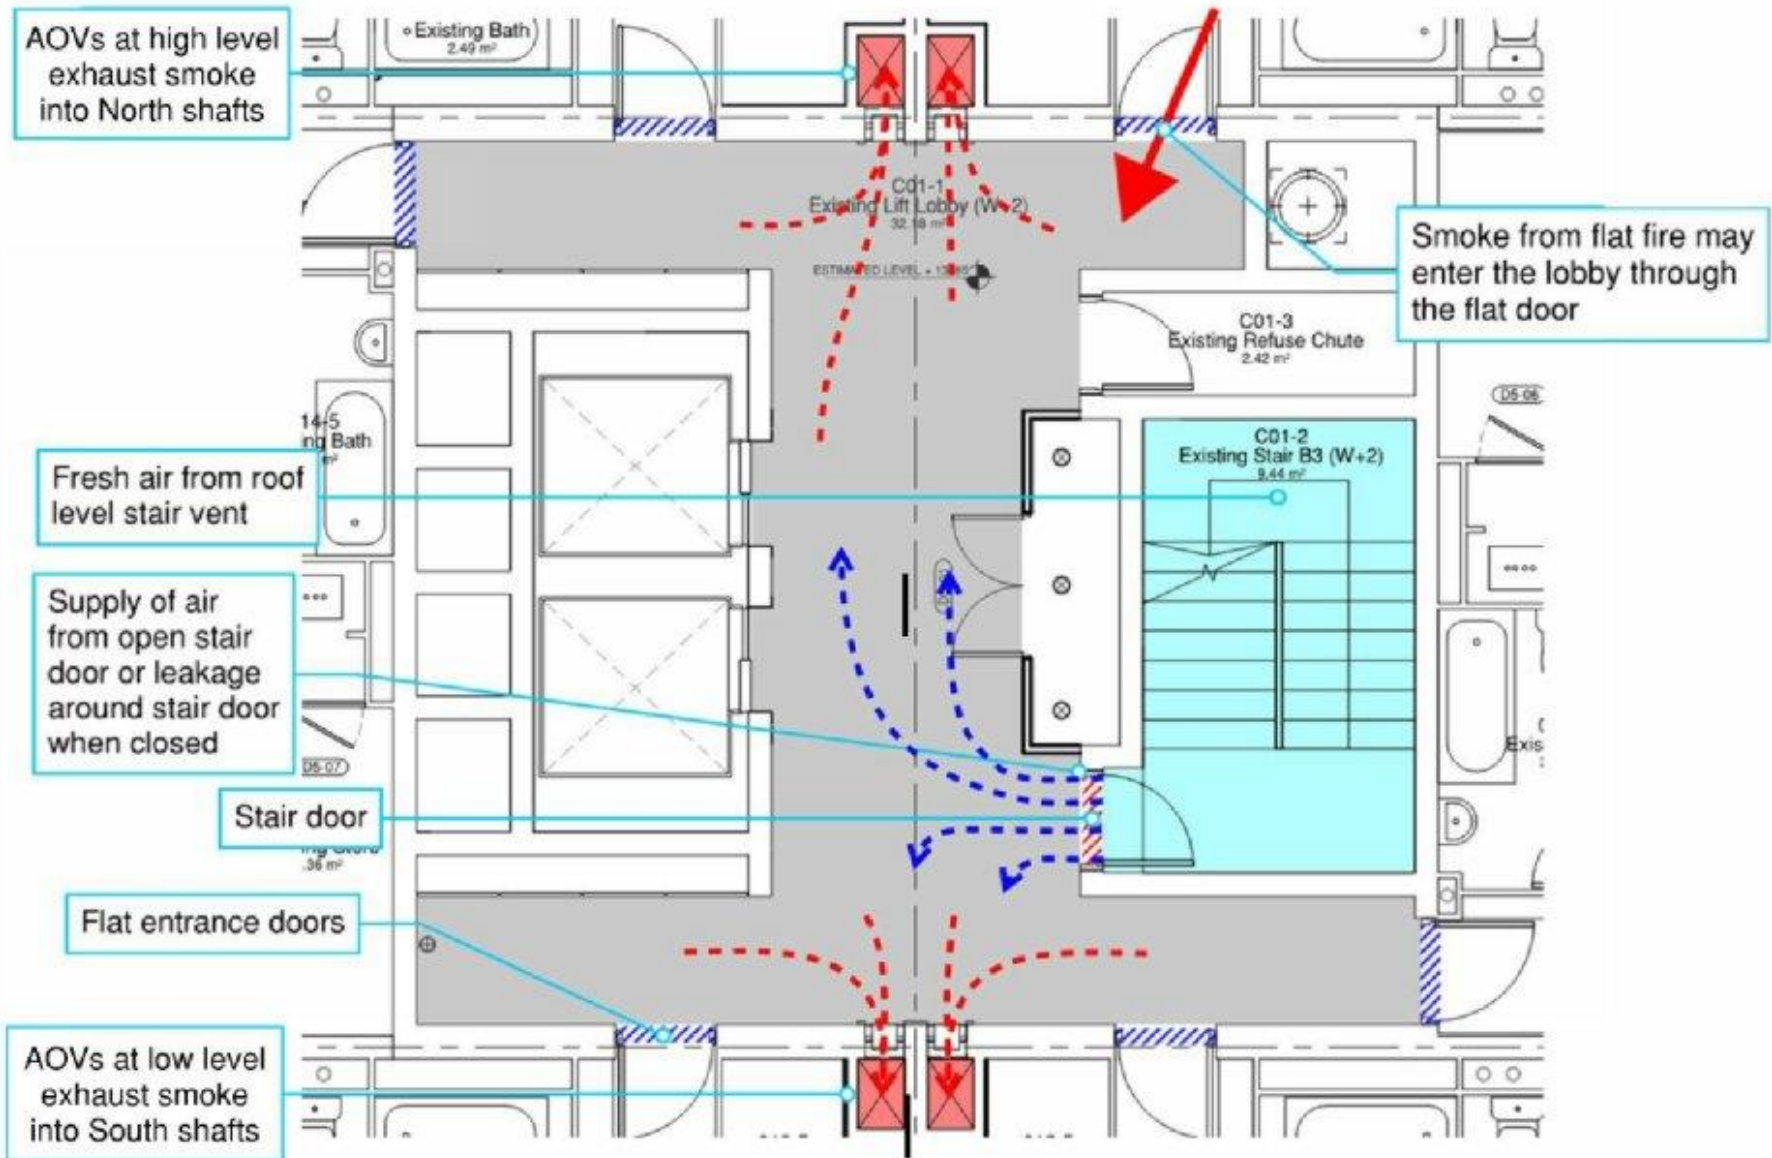
Figure J.7: Operation of the refurbished smoke ventilation system on the fire floor, overlaid on an excerpt from SEA00010474.

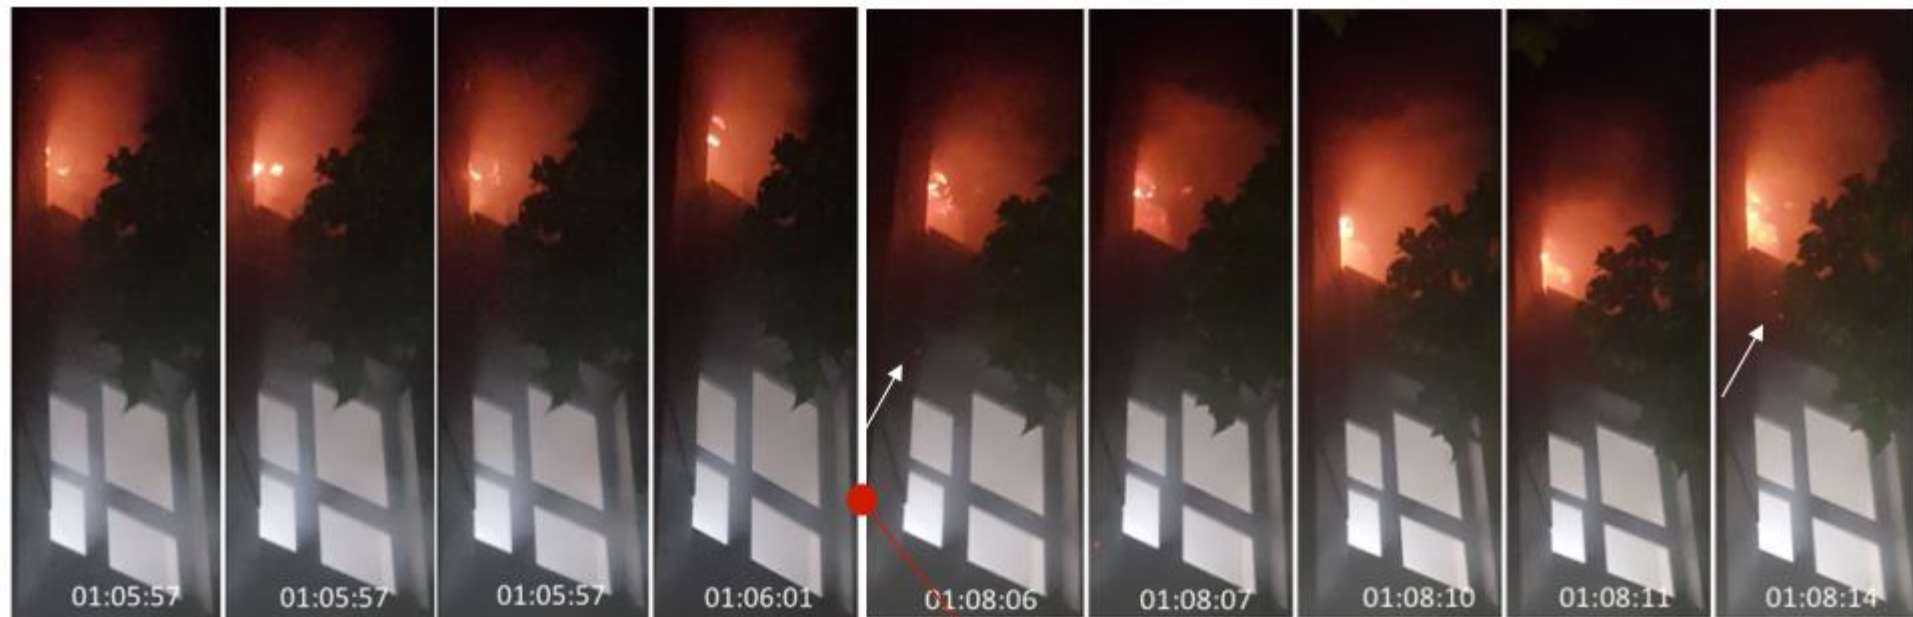
Fire fighters break down the door of flat 16 at approximately 01:07:23.

Fire fighters open the door of the kitchen of flat 16 for the first time at approximately 01:14:16

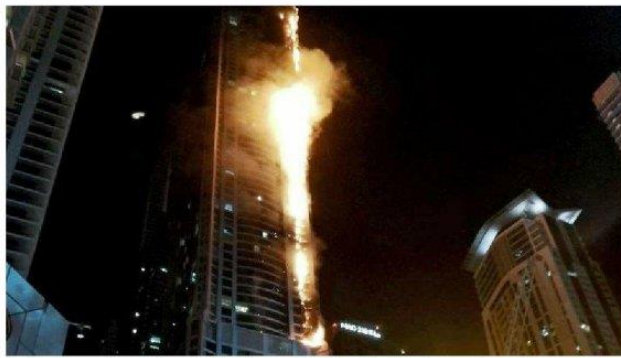
(a) The Torch Building (Dubai) during the fire

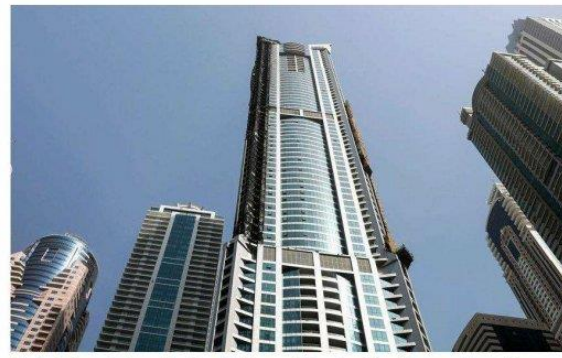
(b) The Torch Building (Dubai) after the fire

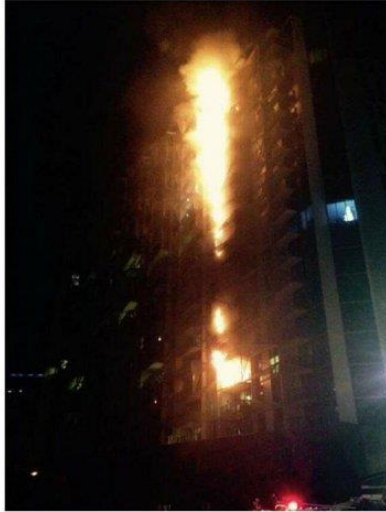
(c) The Lacrosse Building (Melbourne) during the fire

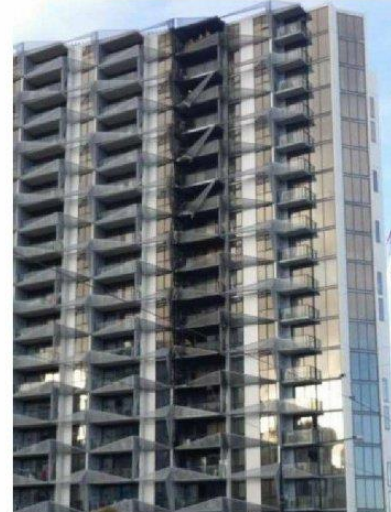
(d) The Lacrosse Building (Melbourne) after the fire

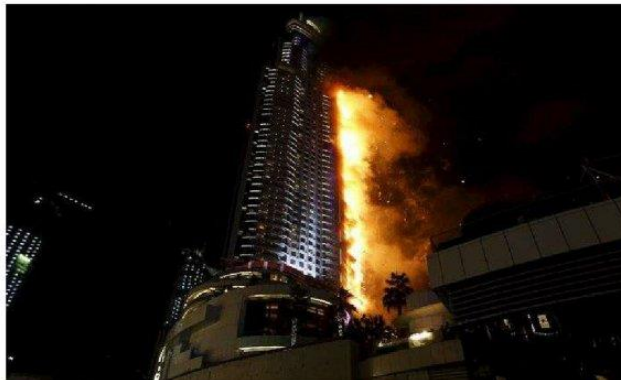
(e) The Address Building (Dubai) during the fire

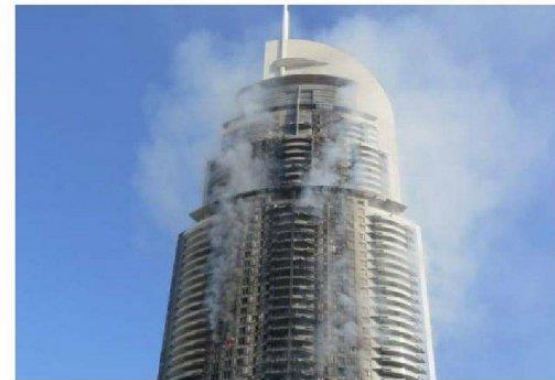
(f) The Address building (Dubai) after the fire
