# BRAND SCHUTZ FORUM MÜNCHEN

Hochhausbrand Grenfell Tower –  
Erkenntnisse für den Brandschutz  
mehrgeschossiger Gebäude

Grenfell Tower Fire – London - 14.06.2017

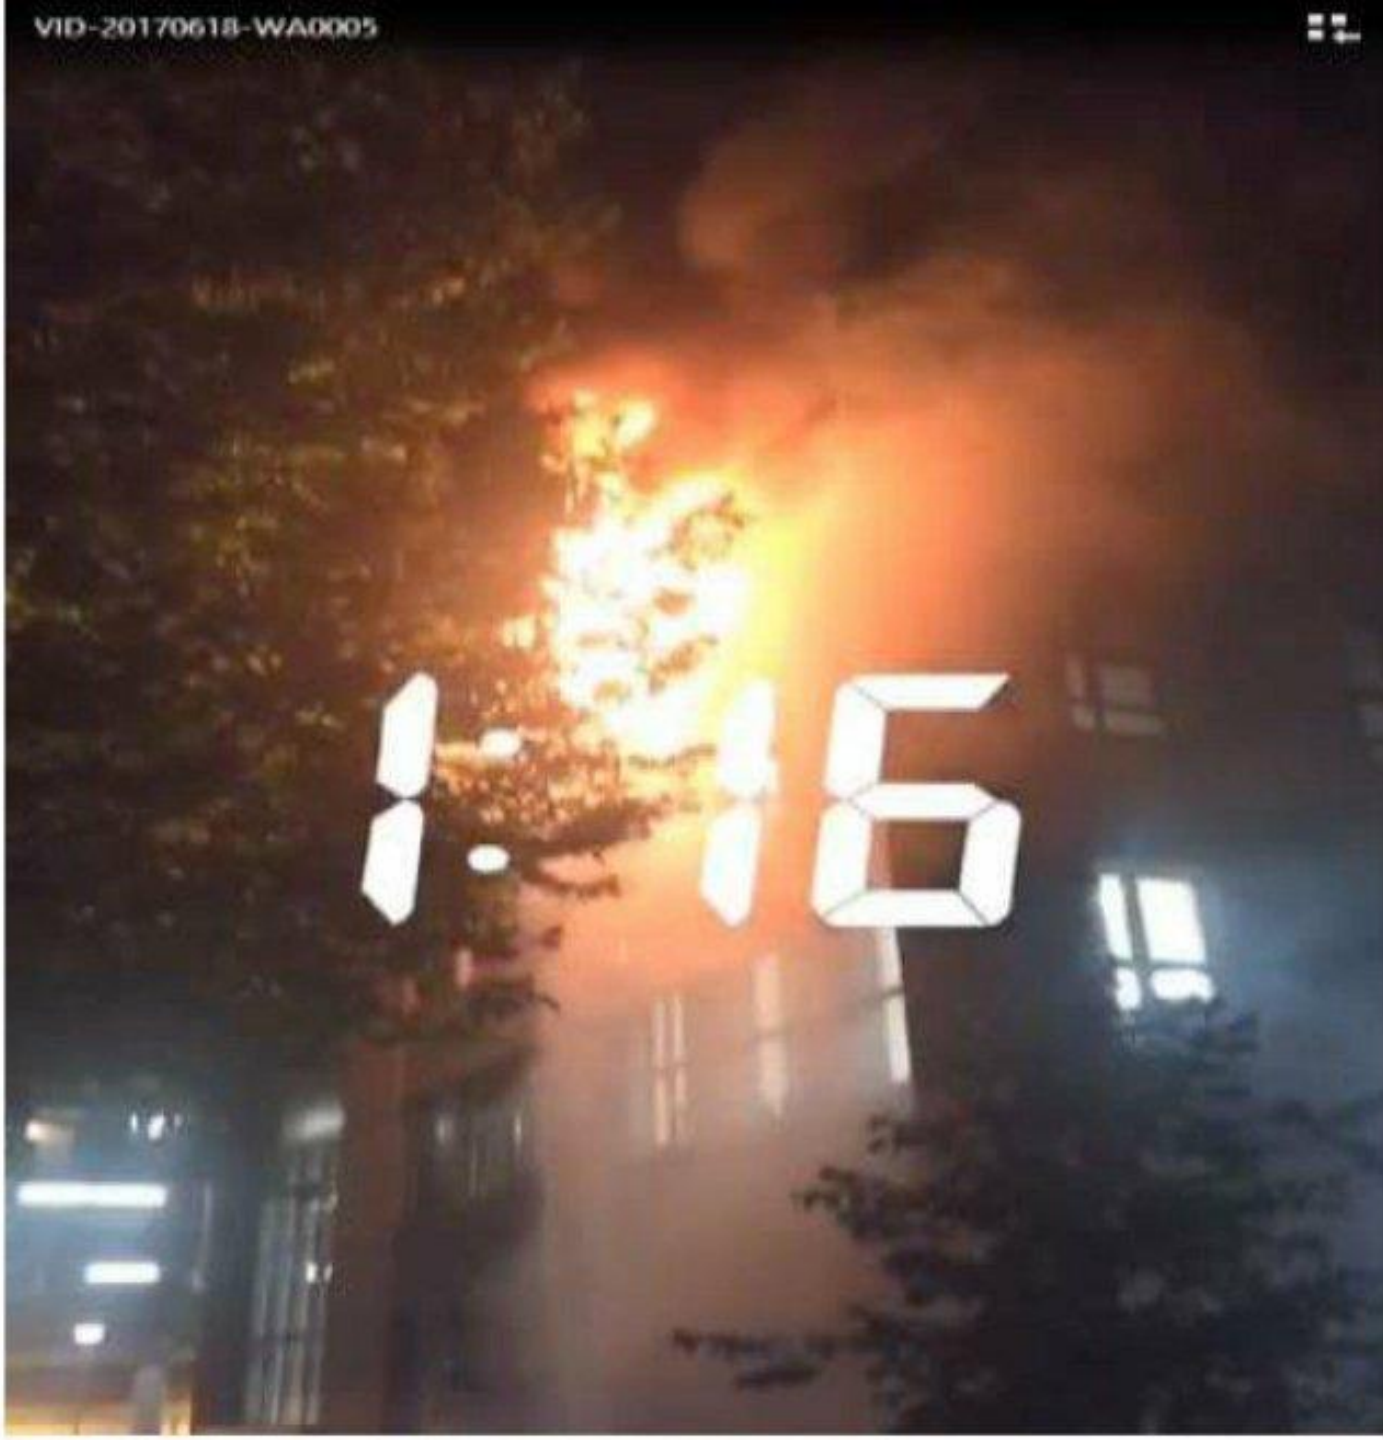
**Sliding  
door**

**Extractor**

**Filler panel**

**Large window  
pane**

**Small window  
pane**

- The intensity of the heat was such that the glass in the windows inevitably failed, allowing the fire to penetrate flats.
  - Extractor fan units in the kitchens had a propensity to deform and become dislodged, providing a point of entry.

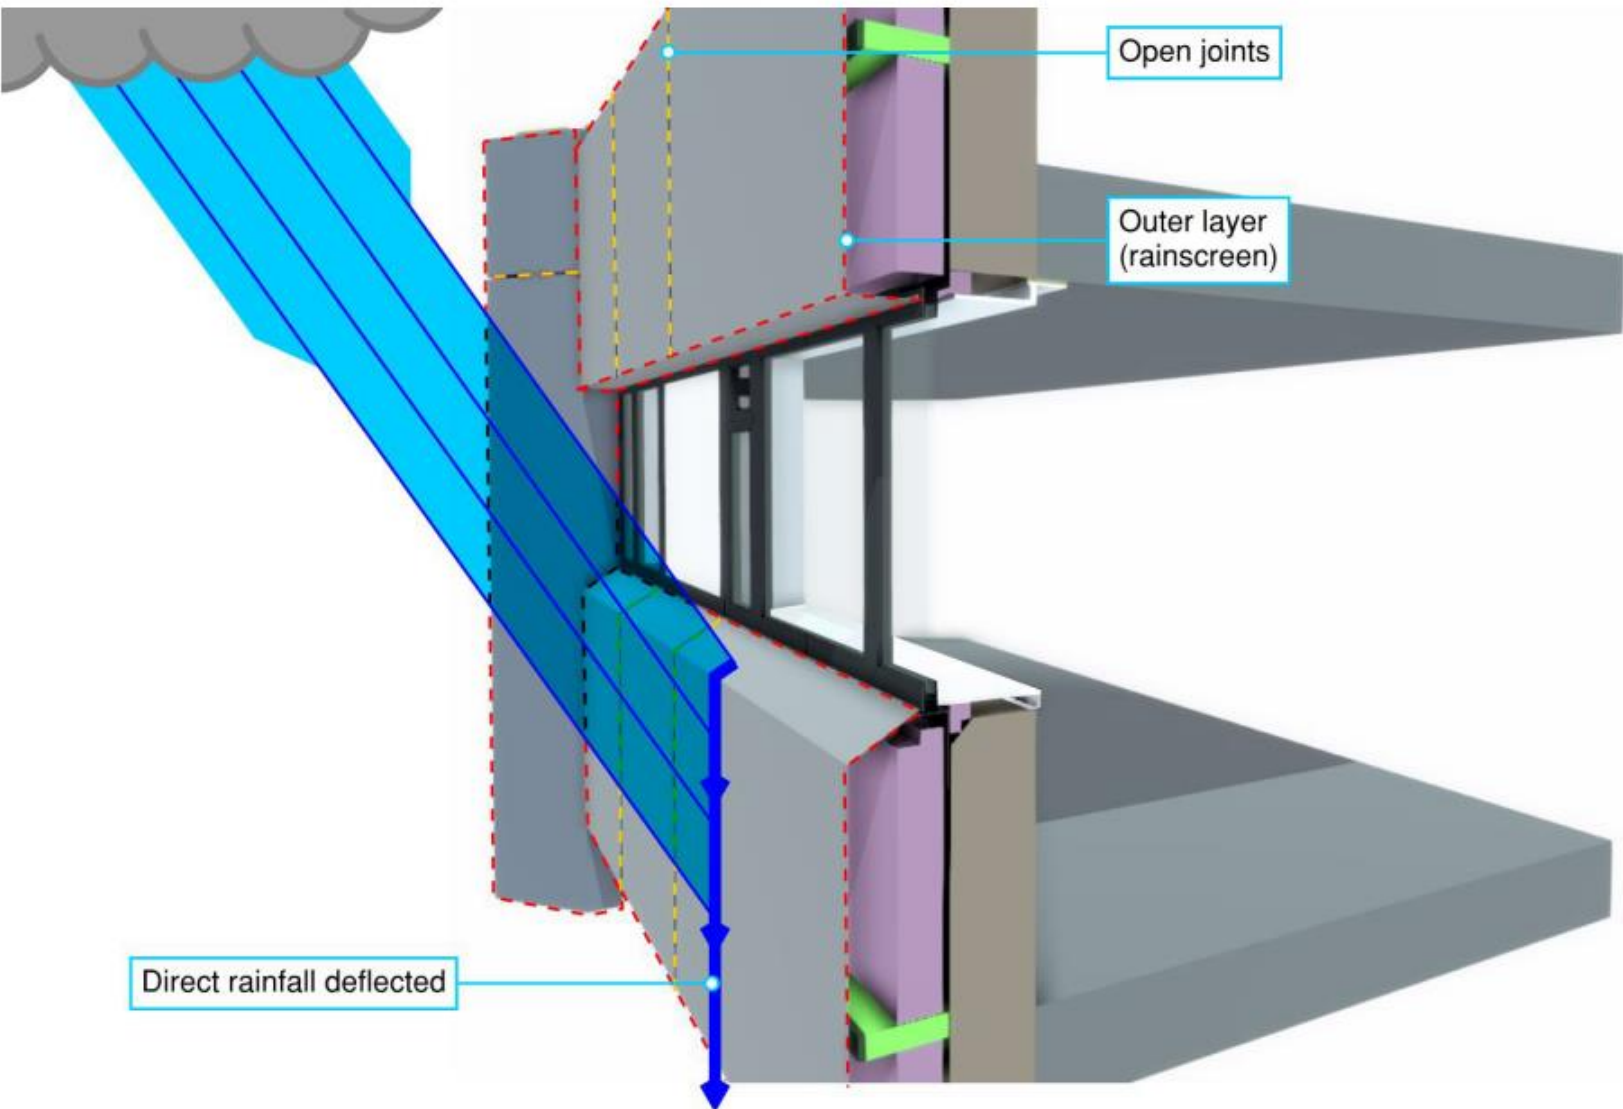
# Rainscreen system: Outer layer

Combustible materials should not be used in cladding systems and extensive cavities.

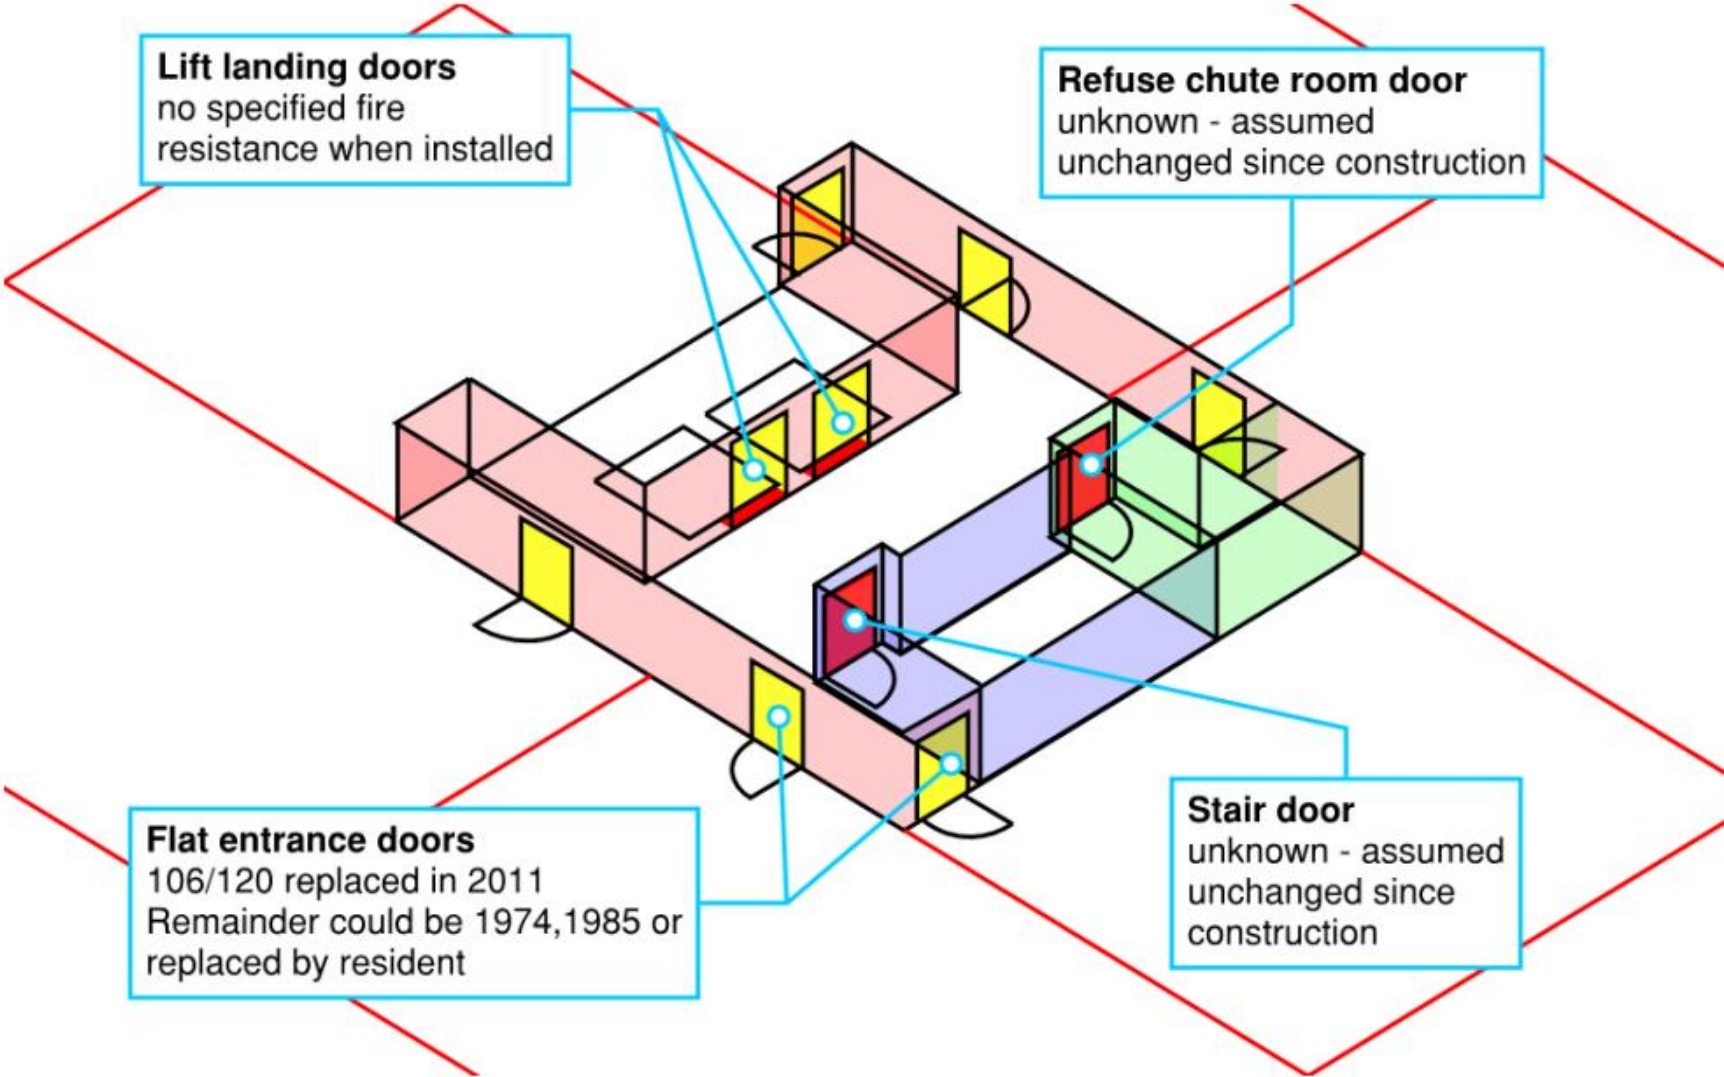
# Conclusion – Condition on night of 14<sup>th</sup> June 2017

- A number of key fire protection measures inside the tower failed. Although some fire doors held back the smoke, others did not. Some were left open and failed to close because they lacked effective self-closing devices; others were broken down by firefighters or wedged open with firefighting equipment.

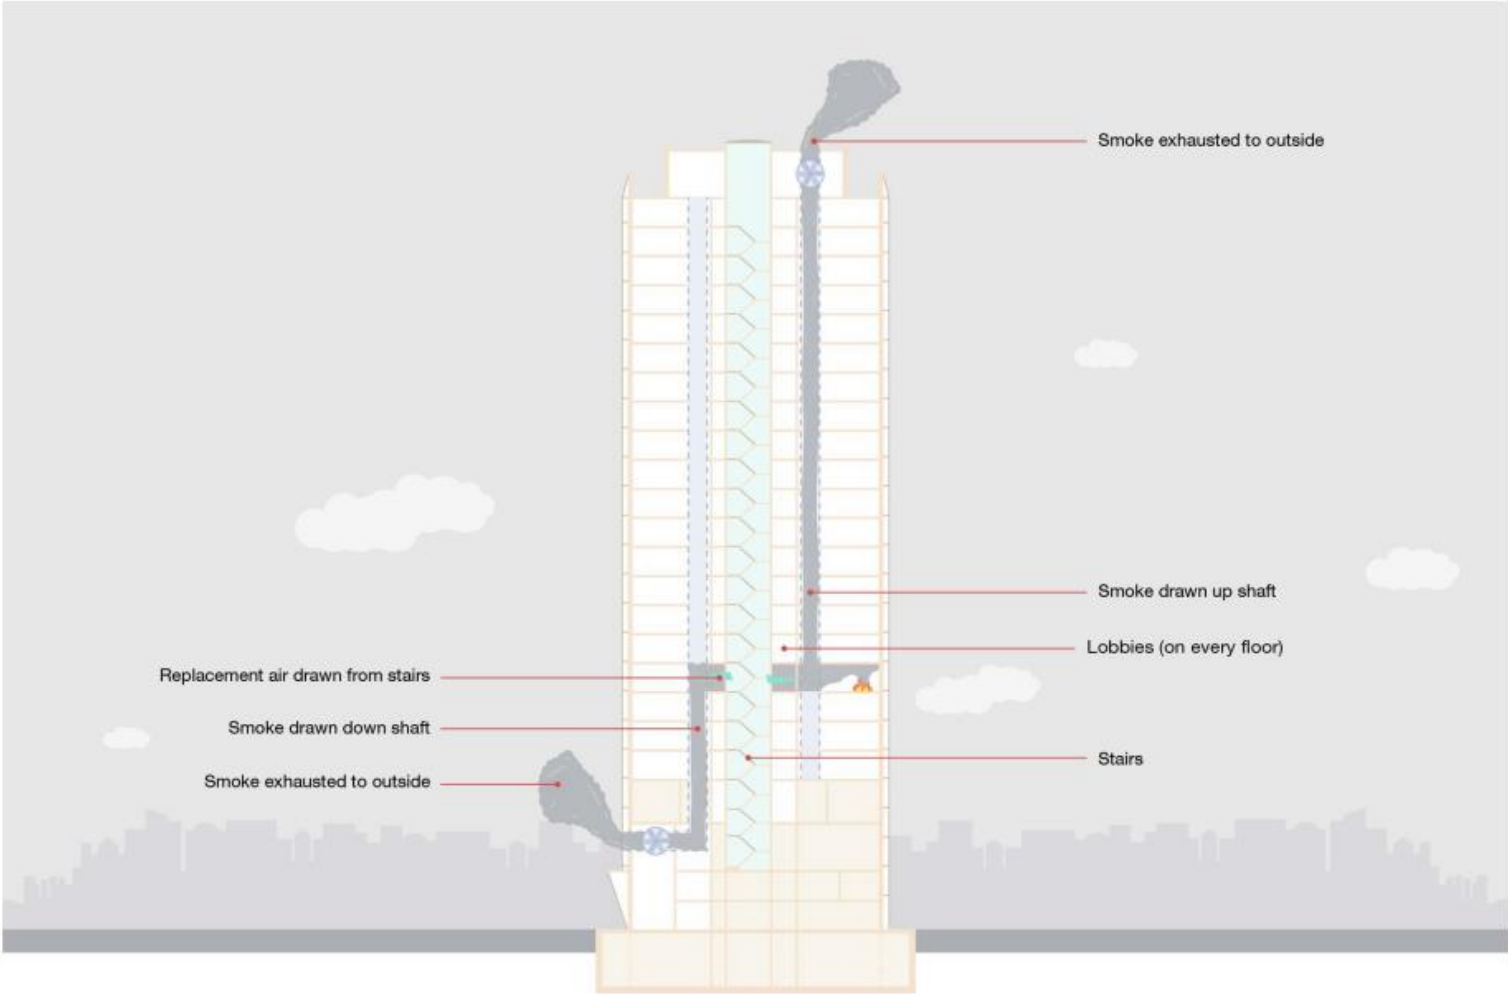
Figure J.5: Operation of the original smoke ventilation system on the fire floor, overlaid on an excerpt from SEA00010474.

# Operation of the combined lobby environmental and smoke control system

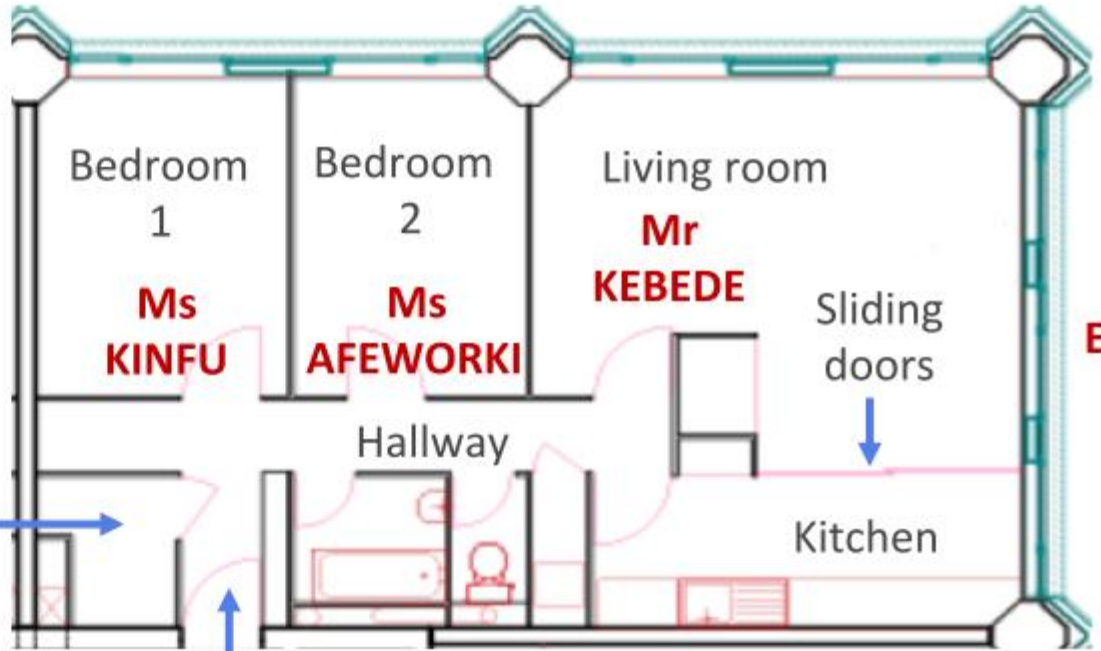
Figure J.7: Operation of the refurbished smoke ventilation system on the fire floor, overlaid on an excerpt from SEA00010474.

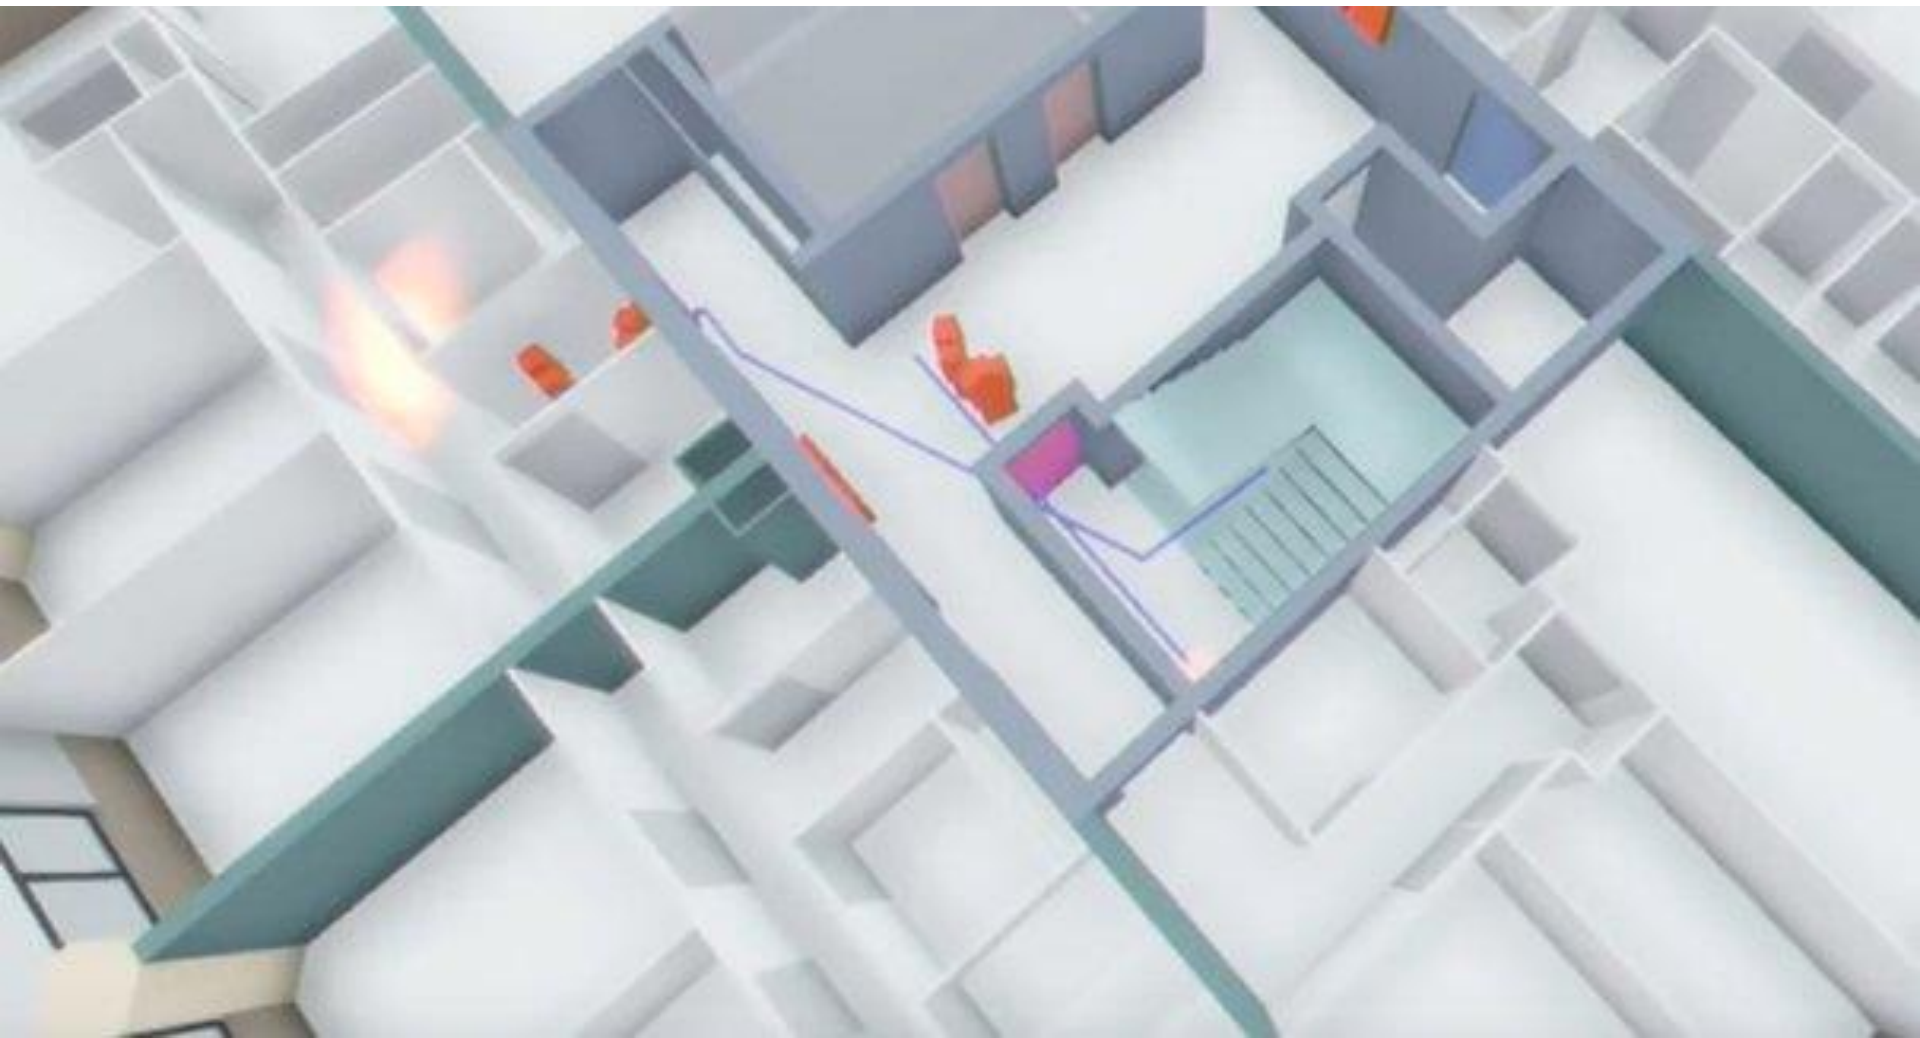
## Initial deployment of London Fire Brigade to Grenfell Tower.

Resource code	Station	Time of deployment	Recorded Time of arrival
G271	North Kensington	00:55:14	00:59:28
G272	North Kensington	00:55:14	00:59:24
G331	Kensington	00:55:14	01:08:33
G362	Hammersmith	00:59:12	01:08:27

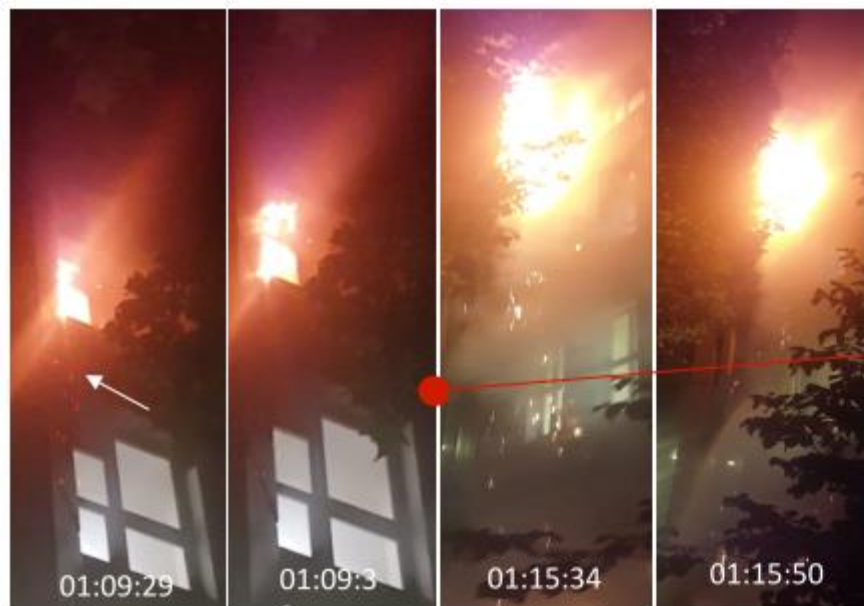
Fire fighters break down the door of flat 16 at approximately 01:07:23.

Fire fighters open the door of the kitchen of flat 16 for the first time at approximately 01:14:16
